FAILURE OF TETON DAM

A REPORT OF FINDINGS

by
U.S. DEPARTMENT OF THE INTERIOR
TETON DAM FAILURE REVIEW GROUP
April 1977

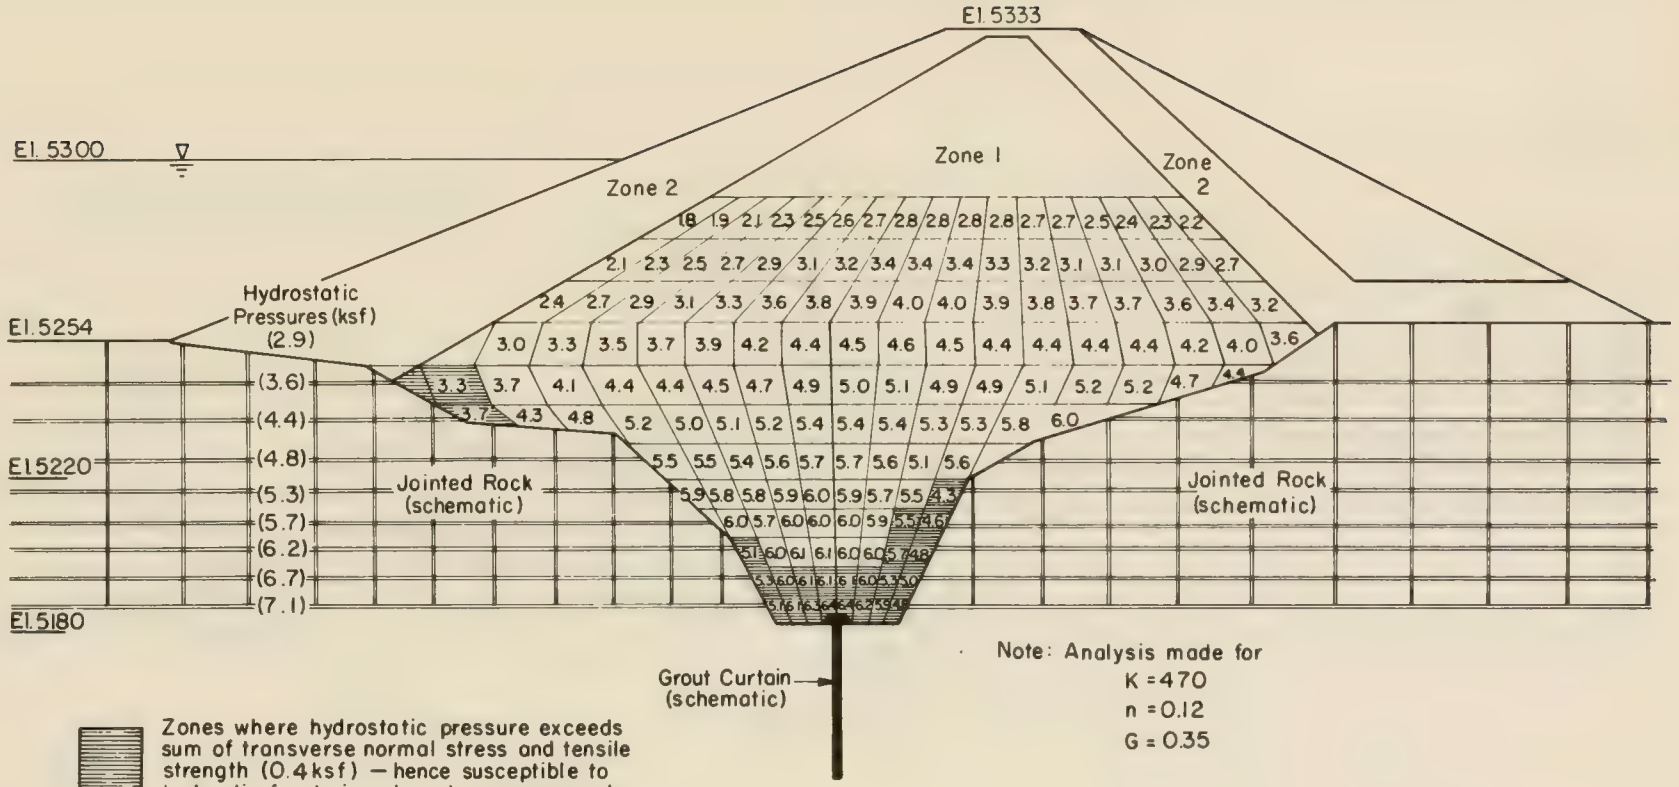
FIG. 12 COMPUTED VALUES OF MINOR PRINCIPAL STRESS IN PLANE OF SECTION STA. 13+70

Analyses similar to those presented above, but for the embankment cross-section at Station 13+70, are shown in Figs. 12 and 13. Fig. 12 shows values of the minor principal stress at element locations throughout Zone 1, together with values of the hydrostatic water pressures in the upstream jointed rock for a reservoir level of 5300 (the level on the day of the failure). The shaded zone shows those parts of the key trench where the water pressure exceeds the sum of the minor principal stress and the estimated tensile strength of the key trench fill, and thus where inclined longitudinal fracturing as shown in Fig. 8 can be expected to occur. It may be seen that such fracturing could extend about 40 ft above the base of the key trench at this section and that longitudinal flow of water along fractures could occur all the way across the section.

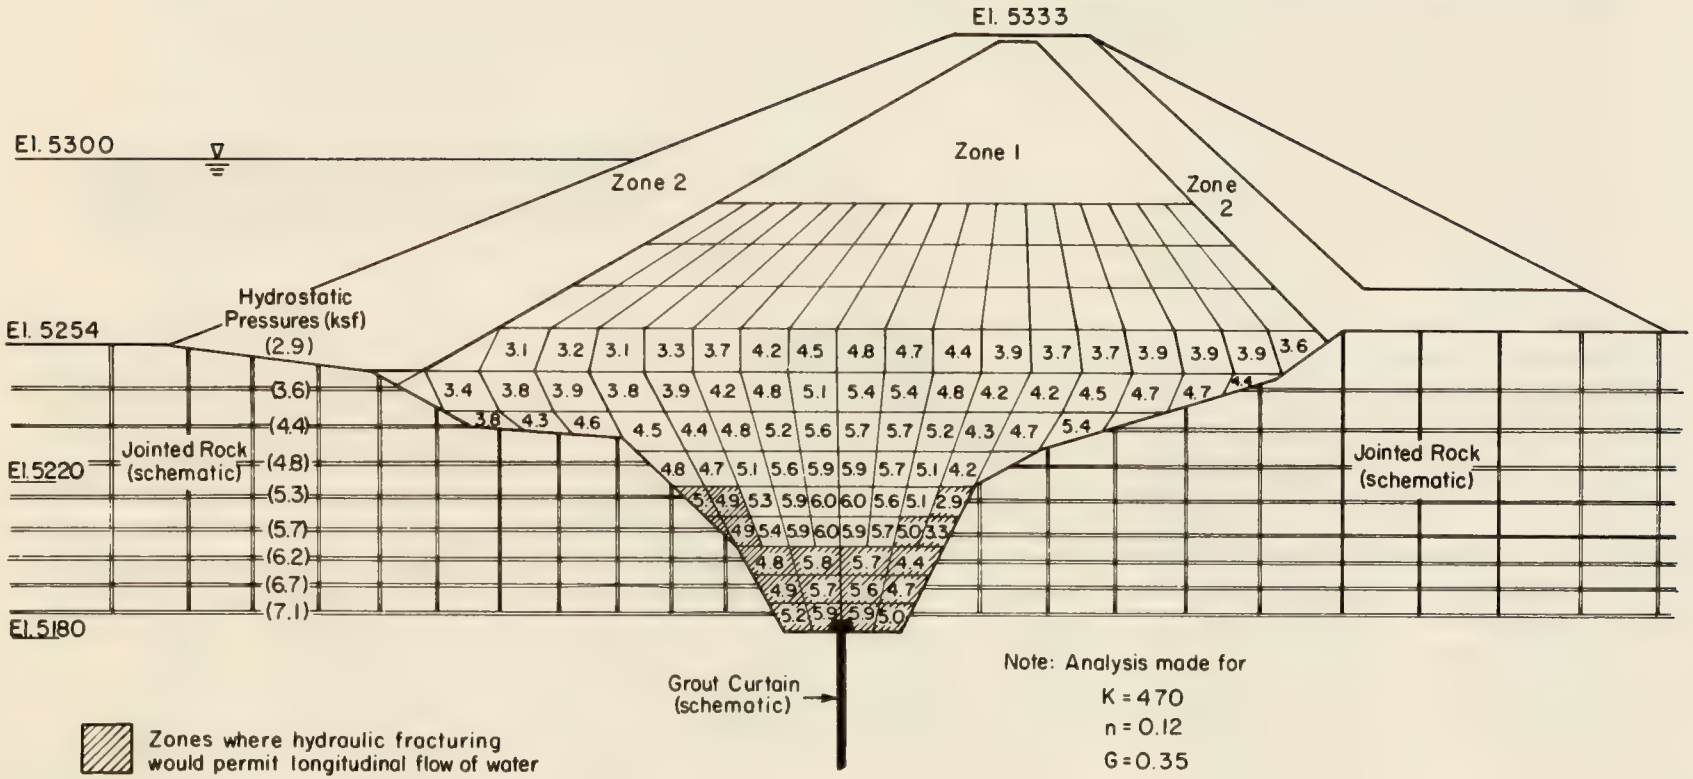
For example with the reservoir level at El. 5255 (as it was on May 20, 1976) the hydrostatic water pressures in the upstream jointed rock would only be sufficient to cause hydraulic fracturing in the bottom 10 ft of the key trench at Station 15+00 and none at all for Stas. 13+70 and 12+70. This condition is best illustrated by the longitudinal section drawn through the centerline of the key trench on the right abutment shown in Fig. 16. The analysis indicates only a very small zone in the vicinity of Sta. 15+00 where the water could move horizontally and vertically through hydraulically-induced fractures on this date, May 20, and for a reservoir level of 5255.

As the water level rose, the extent of the zone in which fracturing could occur naturally increased, but reference to Figs. 11 and 12 will show that even when the reservoir level rose to El. 5275 hydraulic fracturing would still not yet have developed at the bottom of the key trench at Station 13+70. This reservoir elevation was reached on May 25, 1976 and Fig. 17 shows the estimated extent of the zone of hydraulic fracturing in the key trench on this date.

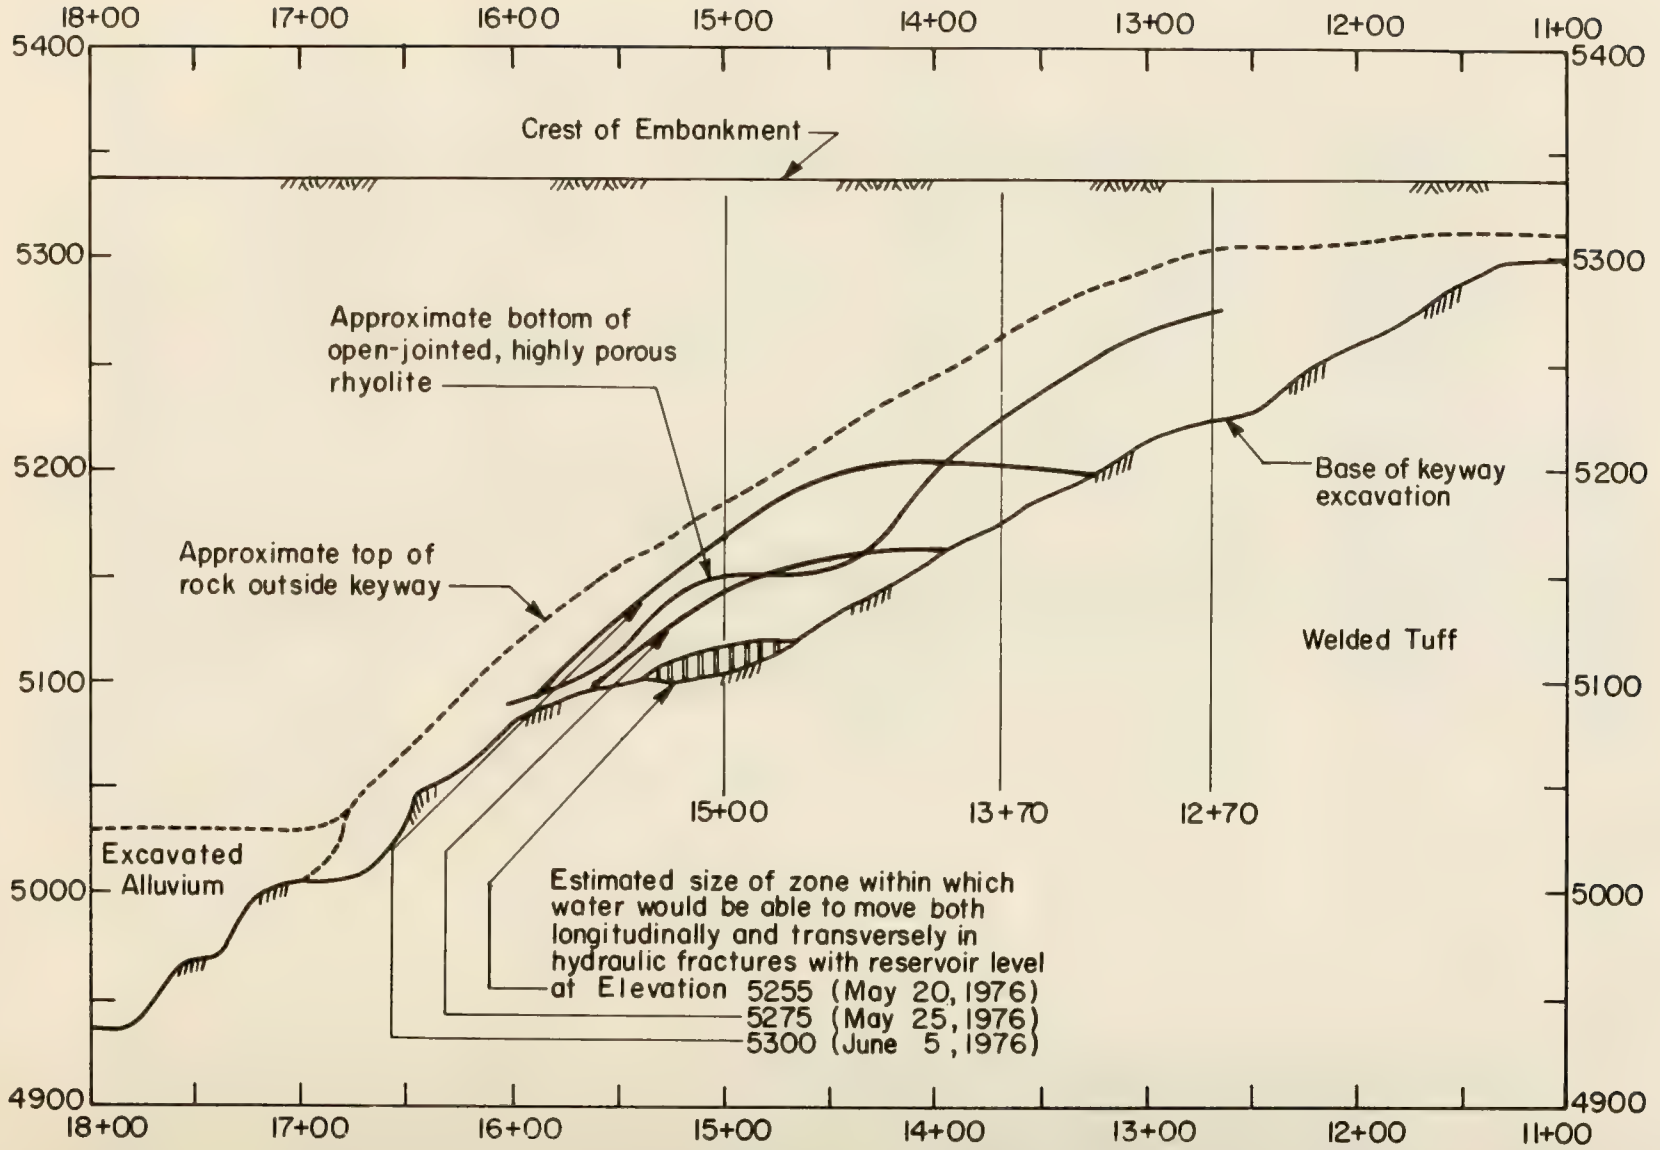
FIG. 16 LONGITUDINAL SECTION THROUGH CENTER LINE CREST AND GROUT CAP

Figs. 16, 17 and 18 provide an excellent summary of the extent of the potential zone of hydraulic fracturing, as estimated from the results of the preceding analytical studies. It is interesting to note that they only indicate the development of a substantial zone of vulnerability due to this cause in the 10 days before failure actually occurred and that the location of the indicated zone of fracturing coincides closely with the zone in which piping finally developed (between about Stations 13+50 and 15+00).

Consideration of the position of this material in conjunction with the estimated extent of the zones of hydraulic fracturing on May 20 (Fig. 16), May 25 (Fig. 17) and June 5 (Fig. 18) would seem to indicate that it was not until the reservoir elevation reached about El. 5290 on June 1 that the

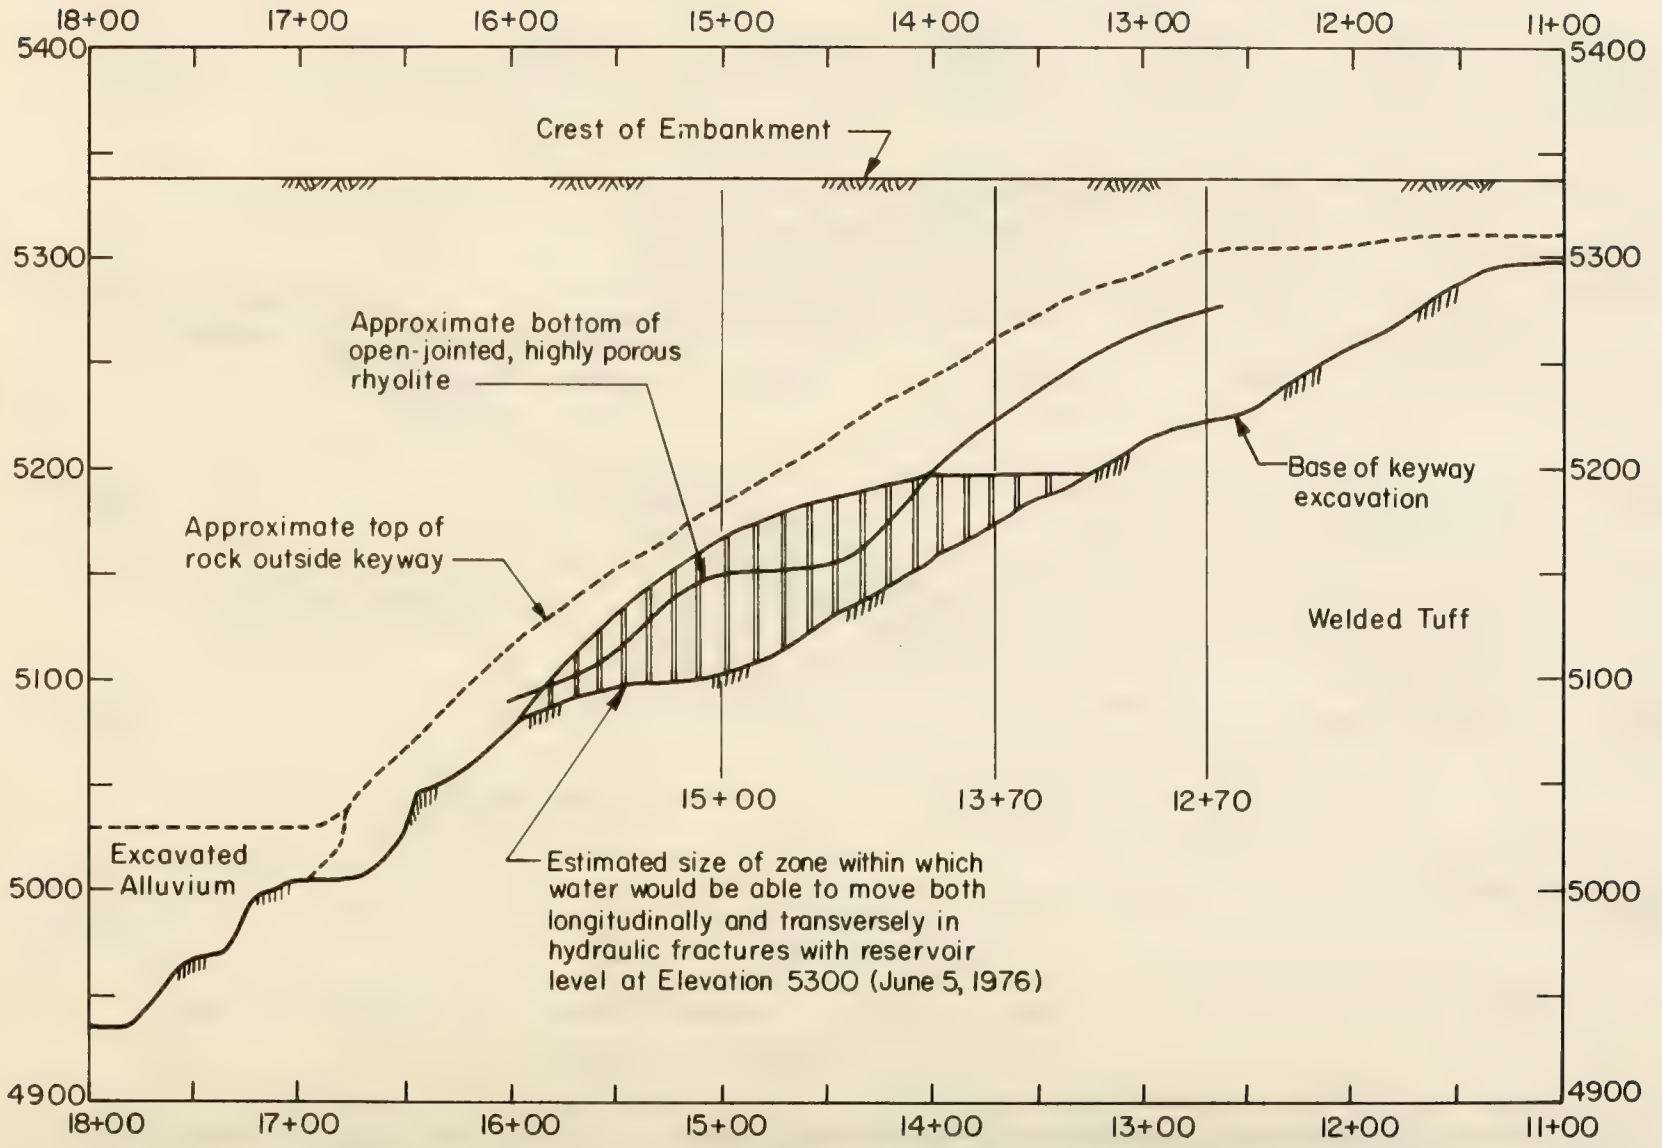
FIG.18 LONGITUDINAL SECTION THROUGH CENTER LINE CREST AND GROUT CAP

Finally, by the time the reservoir reached El. 5300 on June 5, 1976, transverse hydraulic fracturing would become possible in the bottom section of the key trench at Station 13+70 and it would extend to a greater height at Sta. 15+00 as shown in Fig. 18. Note however that it is never likely to occur beyond about Sta. 16+00 because the key trench downslope of that station was either very shallow or non-existent, and it does not seem likely that it would develop upslope of about Station 13+20 because the stress conditions beyond that point are unfavorable to its development.

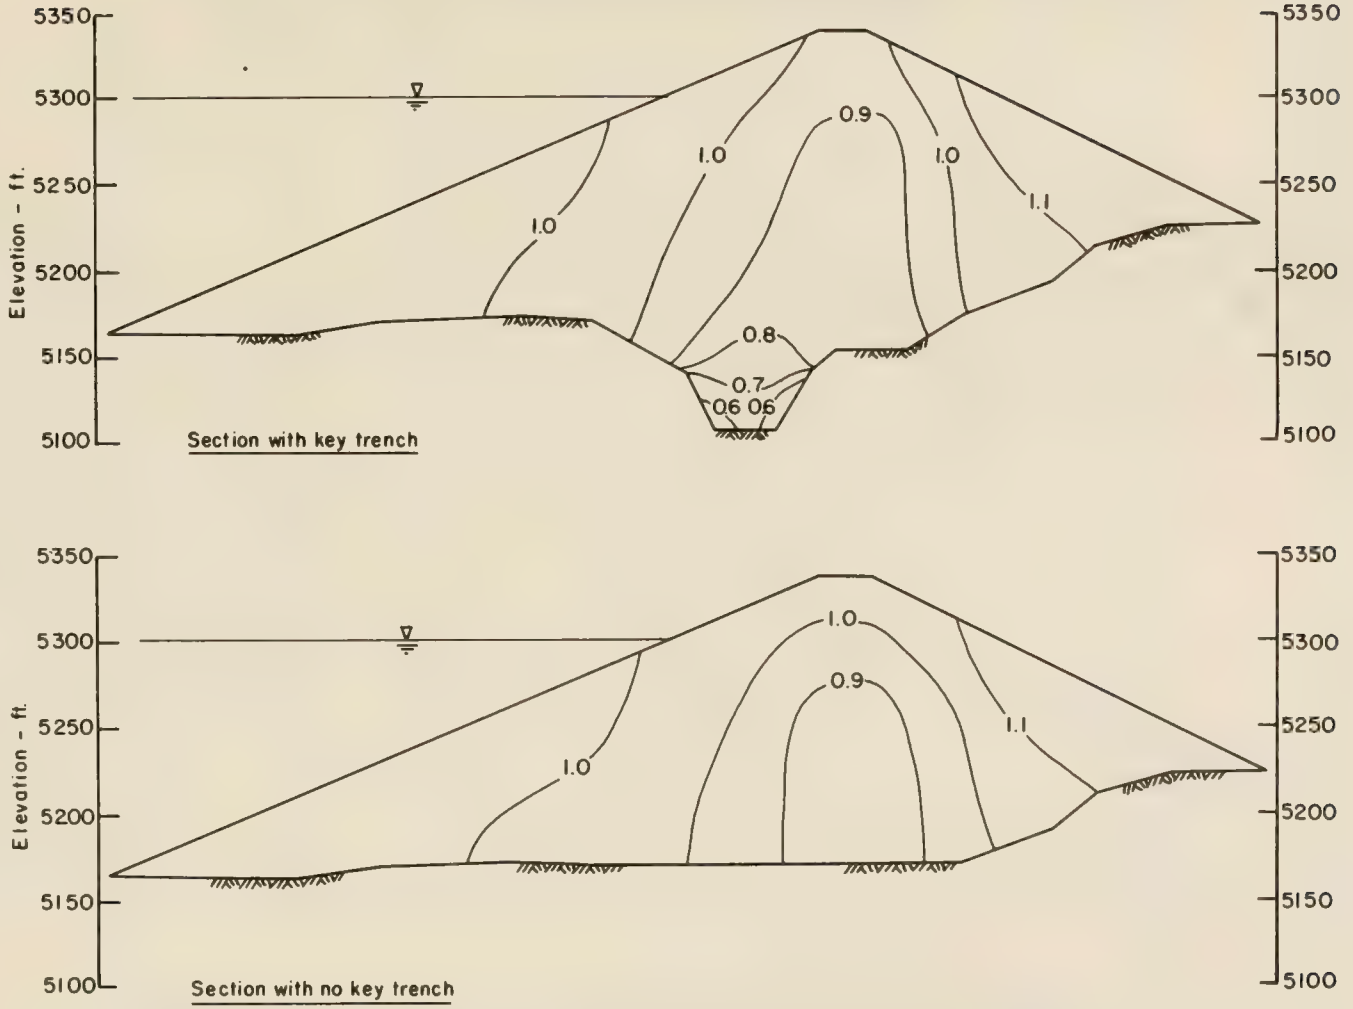
FIG. 19 CONTOURS SHOWING RATIO OF VERTICAL STRESS IN EMBANKMENT TO OVERBURDEN PRESSURE FOR CONDITIONS WITH AND WITHOUT KEY TRENCH AT STA. 15+00 - BEFORE WETTING OF SOIL IN KEY TRENCH

The comparative results for analyses 1 and 2 above are shown in Fig. 19 and for analyses 3 and 4 above in Fig. 20. The effects of arching over the key trench and the considerable reduction in stresses in the key trench fill resulting from the presence of the key trench is readily apparent from these figures, confirming the fact that the use of key trenches on the sides of the abutments invited the development of arching, stress reduction and the accompanying onset of hydraulic fracturing and internal erosion.

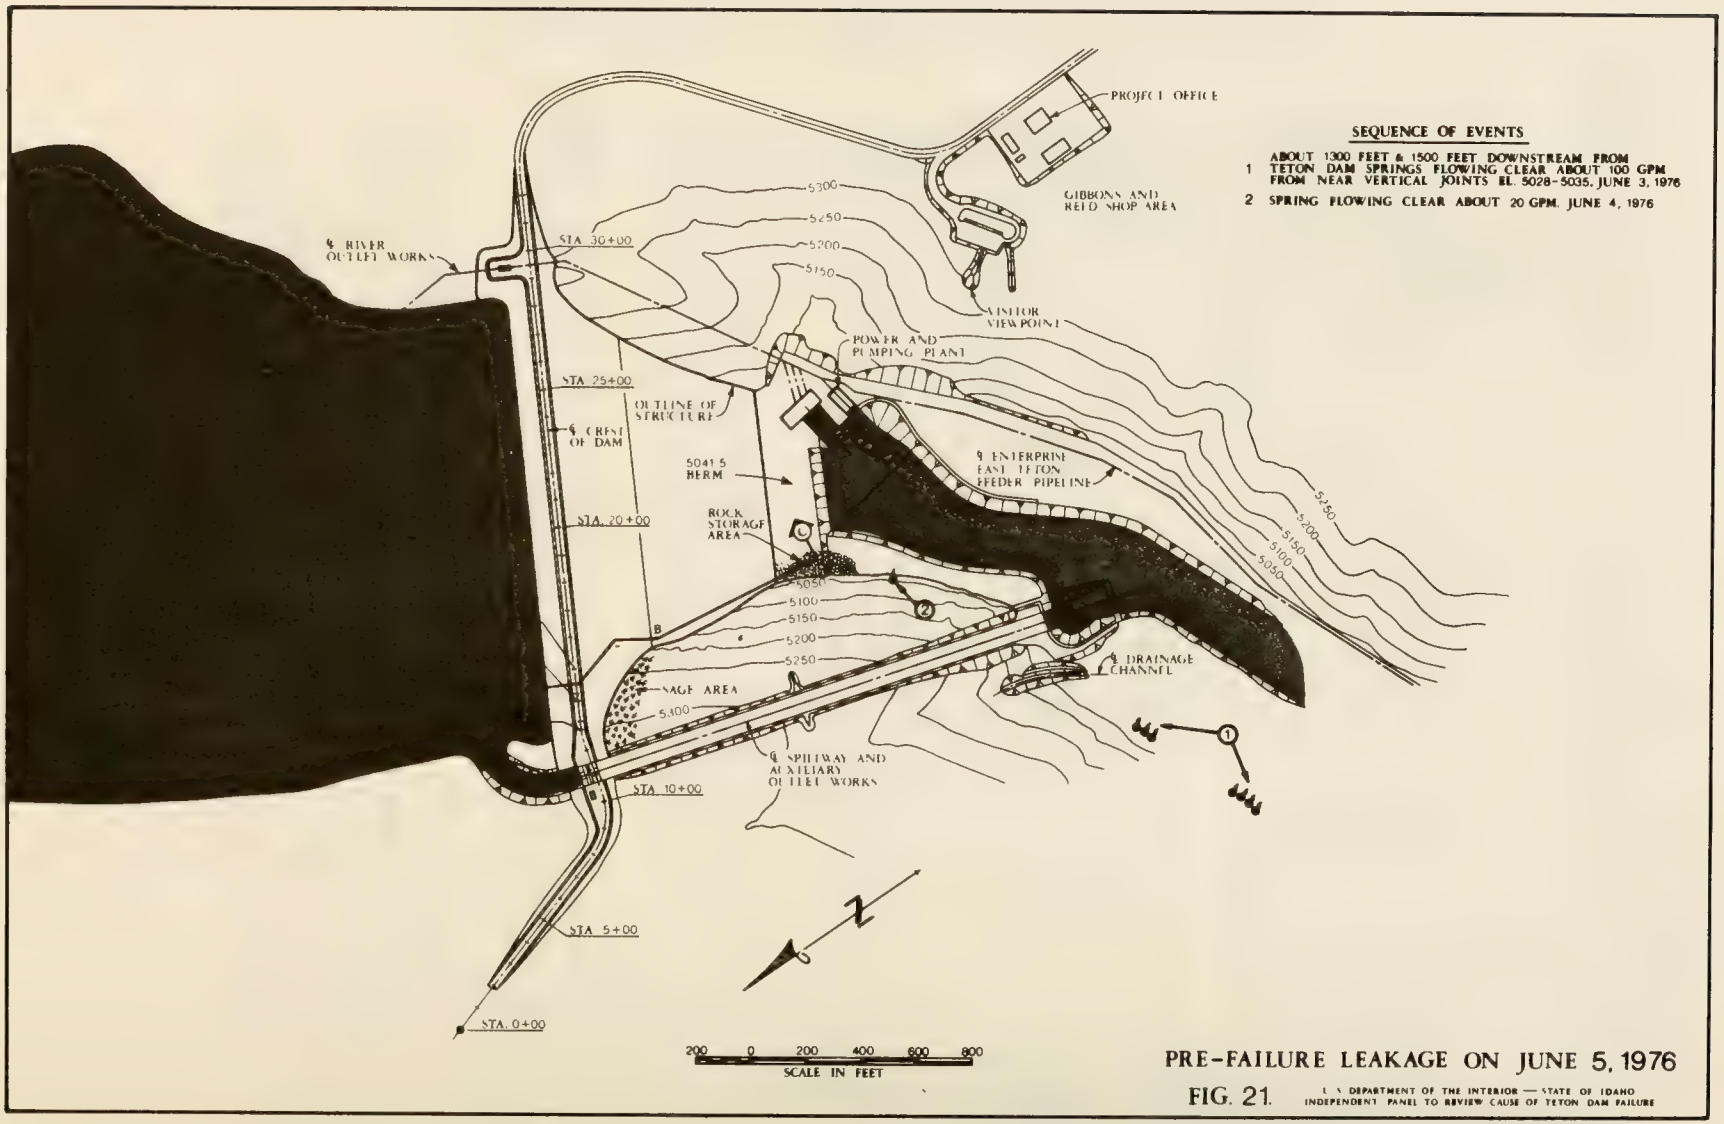
indicate that failure was probably initiated in the key trench in the vicinity of Sta. 14+00, and then progressed downstream approximately along the section ABC shown in Fig. 21. A cross-section through the embankment along section ABC is shown in Fig. 22.

Several days before the final failure, leakage through the key trench fed water at a slowly increasing rate into a number of diagonal joint systems; a portion of this flow entered the joints directly, and a portion entered via the overlying highly fractured rhyolite and talus above El. 5200. As the joint systems began to fill with water, aided by water flow around the end of the right abutment key trench fill, quiet discharges of water occurred several days before the actual failure. Some of the discharges emerged along the base of the canyon wall downstream from the dam (see locations 1 and 2 in Fig. 21) and some moved as subsurface flows into the contact zone of talus and heavily jointed rock beneath the Zone 2 and Zone 5 portions of downstream part of the embankment (Fig. 22).

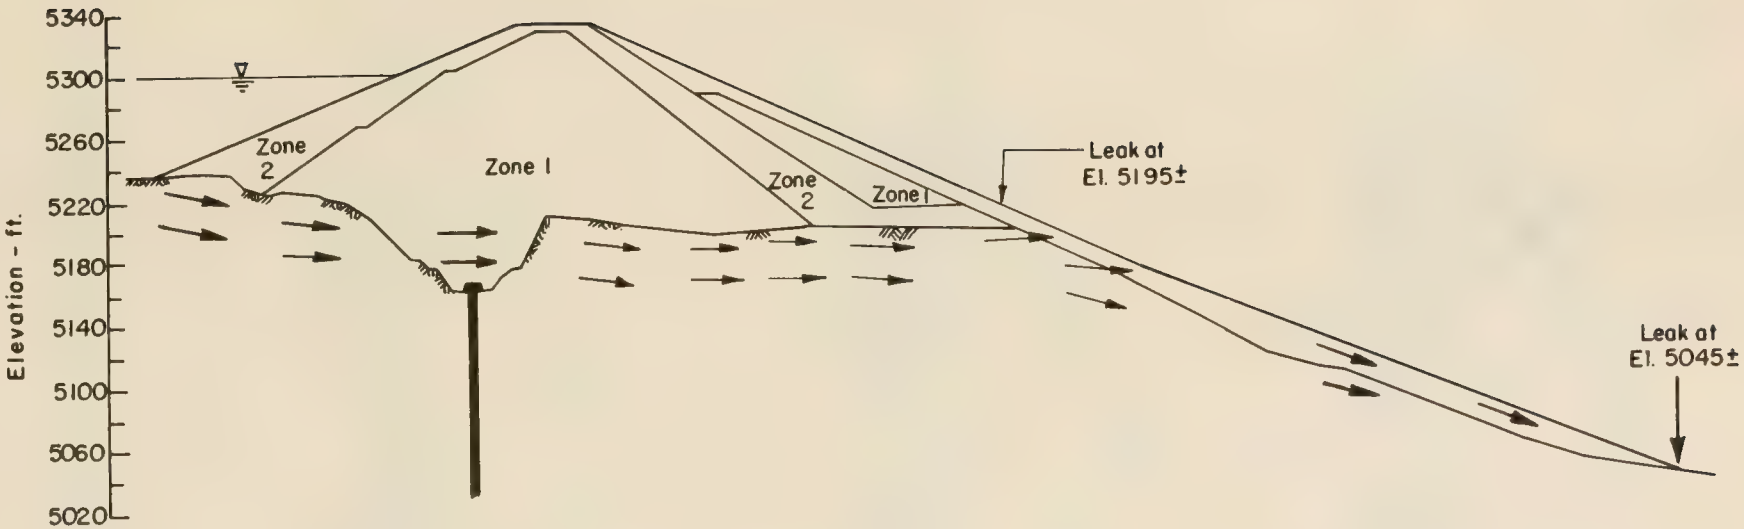
FIG. 22 PROBABLE PATH OF WATER IN EARLY STAGES OF LEAKAGE

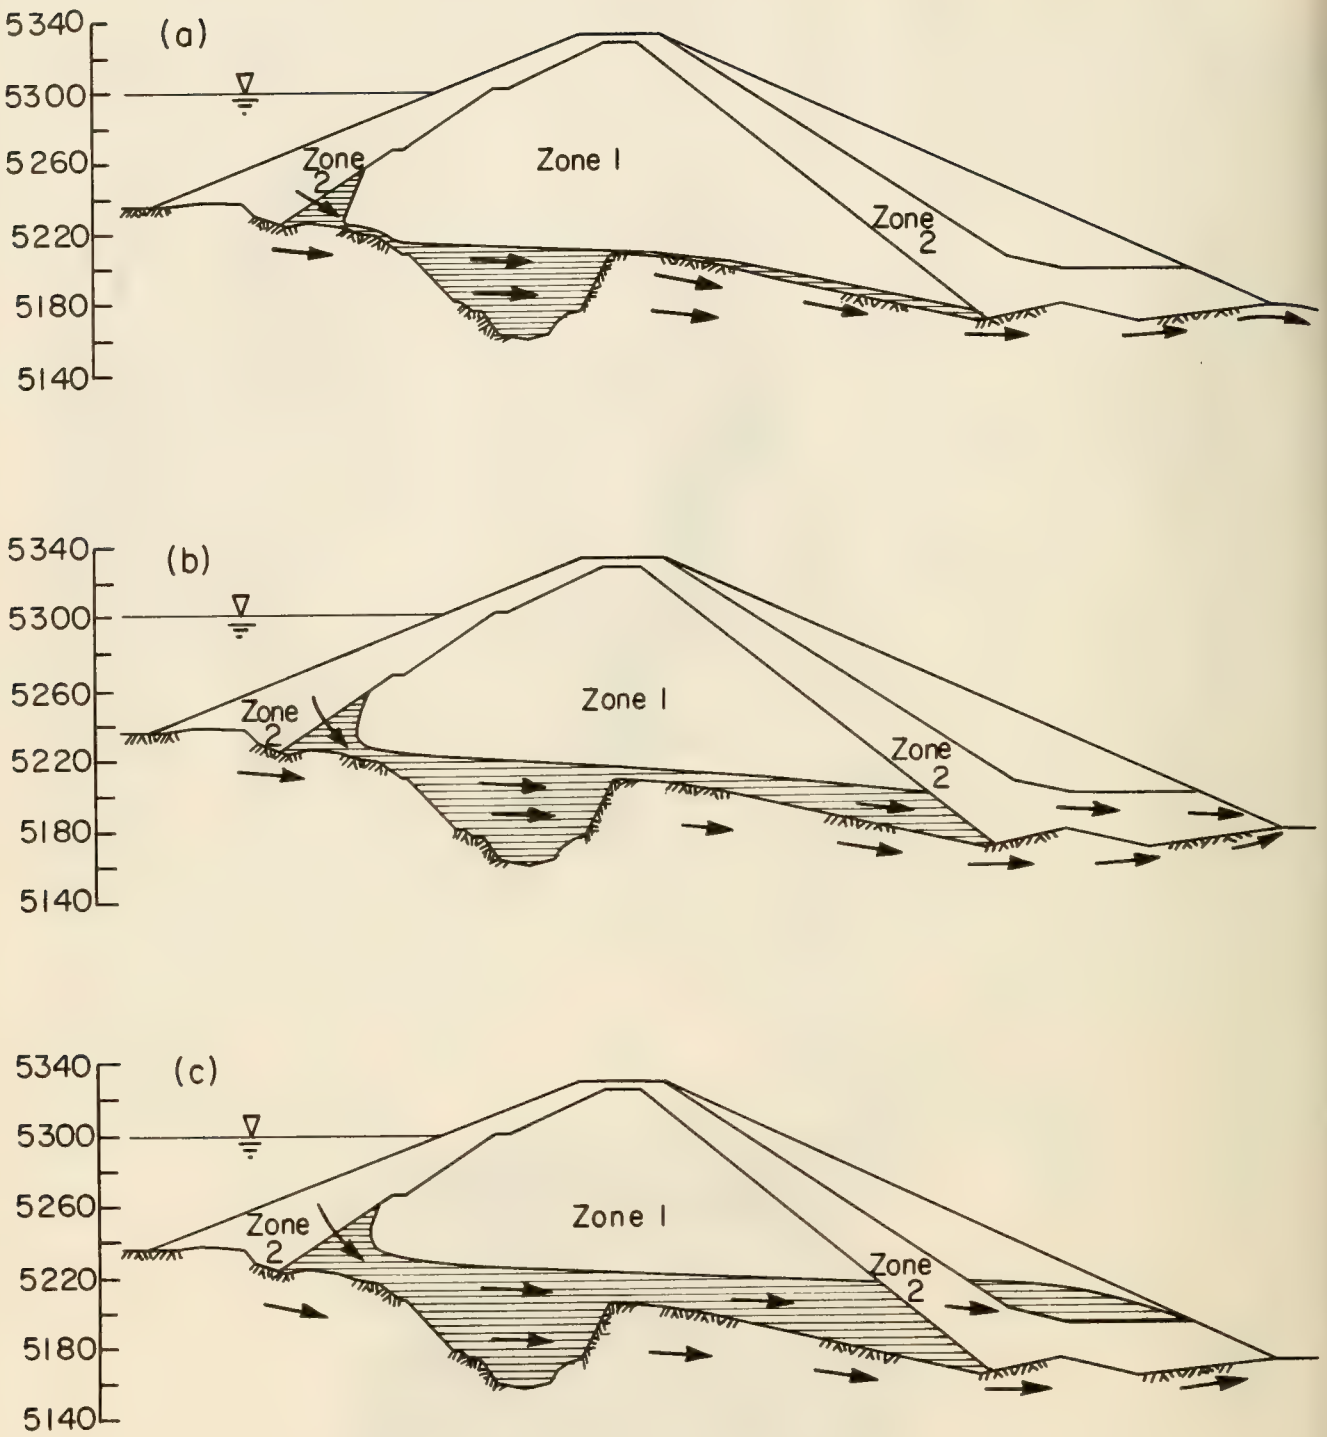
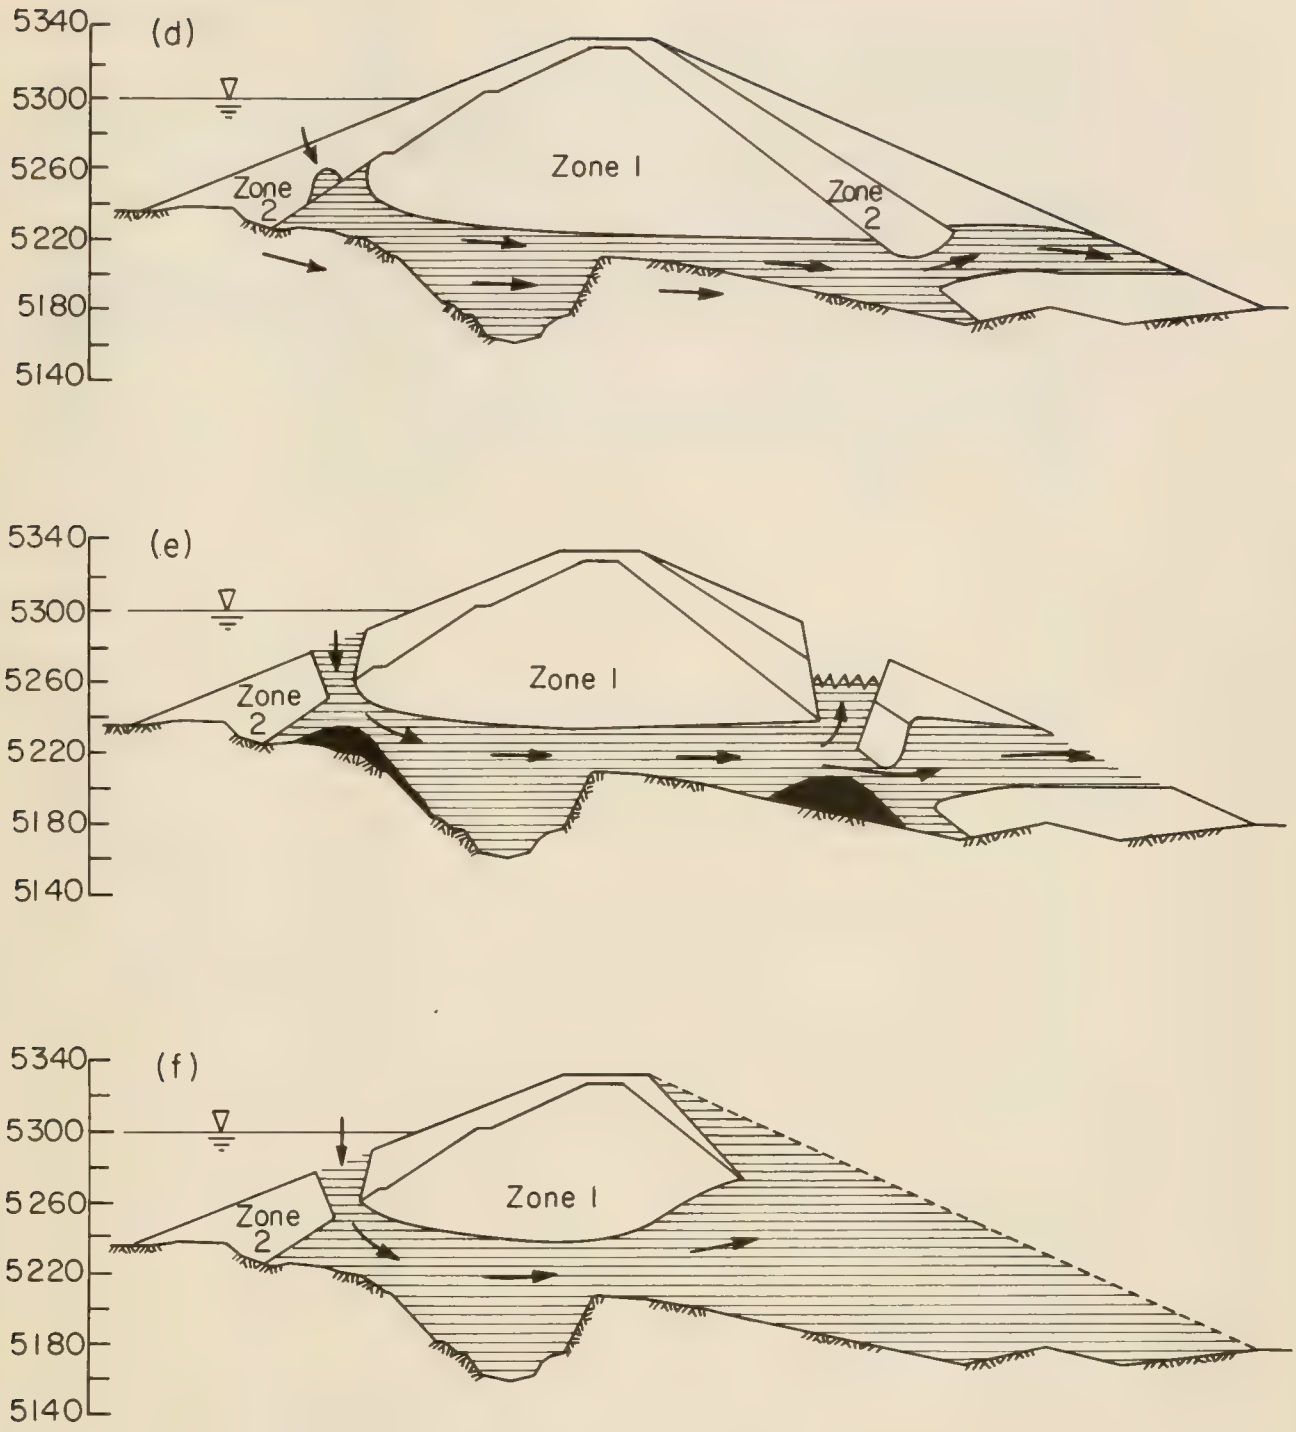
(A, B, C, OF F) FIG. 23 CONCEPTUAL MECHANISM OF PROGRESSIVE FAILURE ALONG SECTION A-B-C
